THE USE OF THE T-CULVERT GUARD TO PROTECT ROAD CULVERTS FROM PLUGGING DAMAGE BY BEAVERS

by K. J. Roblee^{1/}

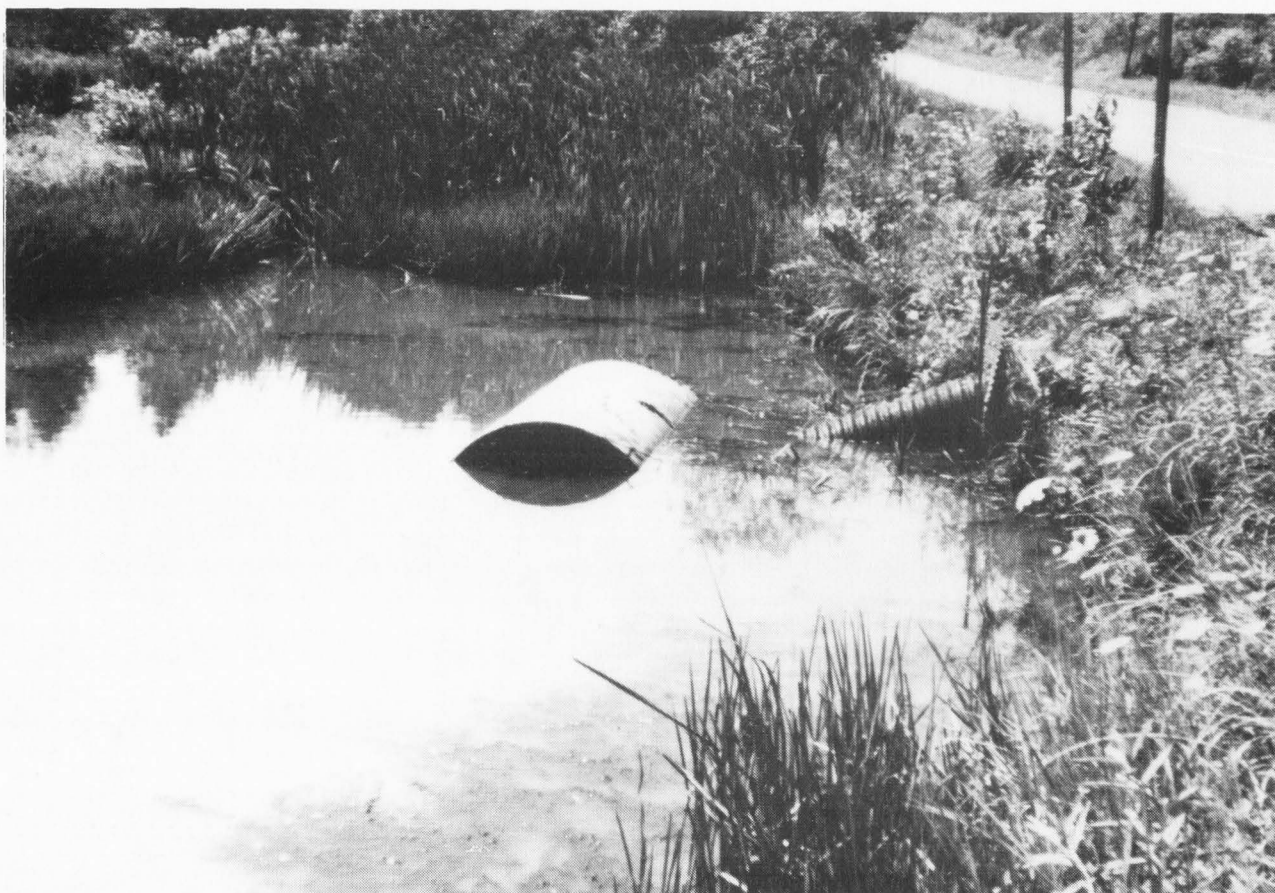
Figure 1 shows a T-culvert in place in front of a road culvert. T-culverts were constructed from new or discarded road culverts of 4 ft. or more diameter, a smaller connecting culvert and concrete reinforcing wire.

Figure 1. Typical T-culvert guard in place at a culvert damage site. Large culvert is perpendicular to road culvert and parallel to road surface.

The 4 trial T-culverts were constructed in the following manner. The two culverts used for construction of a T-culvert may be either corrugated aluminum or corrugated galvanized steel. The large diameter culvert is used to create inlets for the road culvert. These inlets experience low water velocities. Such inlets, when exposed to beaver, are rarely plugged. In general, the larger the road culvert and corresponding flow the larger the diameter needed for the large culvert. This will properly reduce water velocity at its exposed inlets. For road culverts of 6 in. - 18 in. diameter, a 4 ft. minimum diameter large culvert is recommended. For road culverts of 20 in. - 36 in. diameter, a 5 ft. or 6 ft. minimum diameter culvert is recommended. A smaller diameter culvert is used to connect the road culvert to the large culvert. The diameter of this connecting culvert must be near that of the road culvert so it will not reduce flow into the road culvert excessively. It also must be small enough in diameter to fit into the road culvert 6 or more inches at an upward angle as shown in Figure 1.

space is available at a site the longer length is recommended. A hole is cut in the center of the side of the culvert at approximately 2/3 of the distance from the culvert's top. The diameter of this hole is large enough to allow the connecting culvert to pass into it at an angle approximated by Figure 1. Figure 2 shows the correct location of this hole. The ends of the large culvert are covered with No. 6-gauge reinforcing wire mesh. The mesh is attached with No. 10-gauge galvanized wire passed through holes drilled or burned through the large culvert. It may also be attached by passing the protruding ends of the mesh through premeasured holes and bending them over. Figure 2 shows mesh in place over the culvert ends.

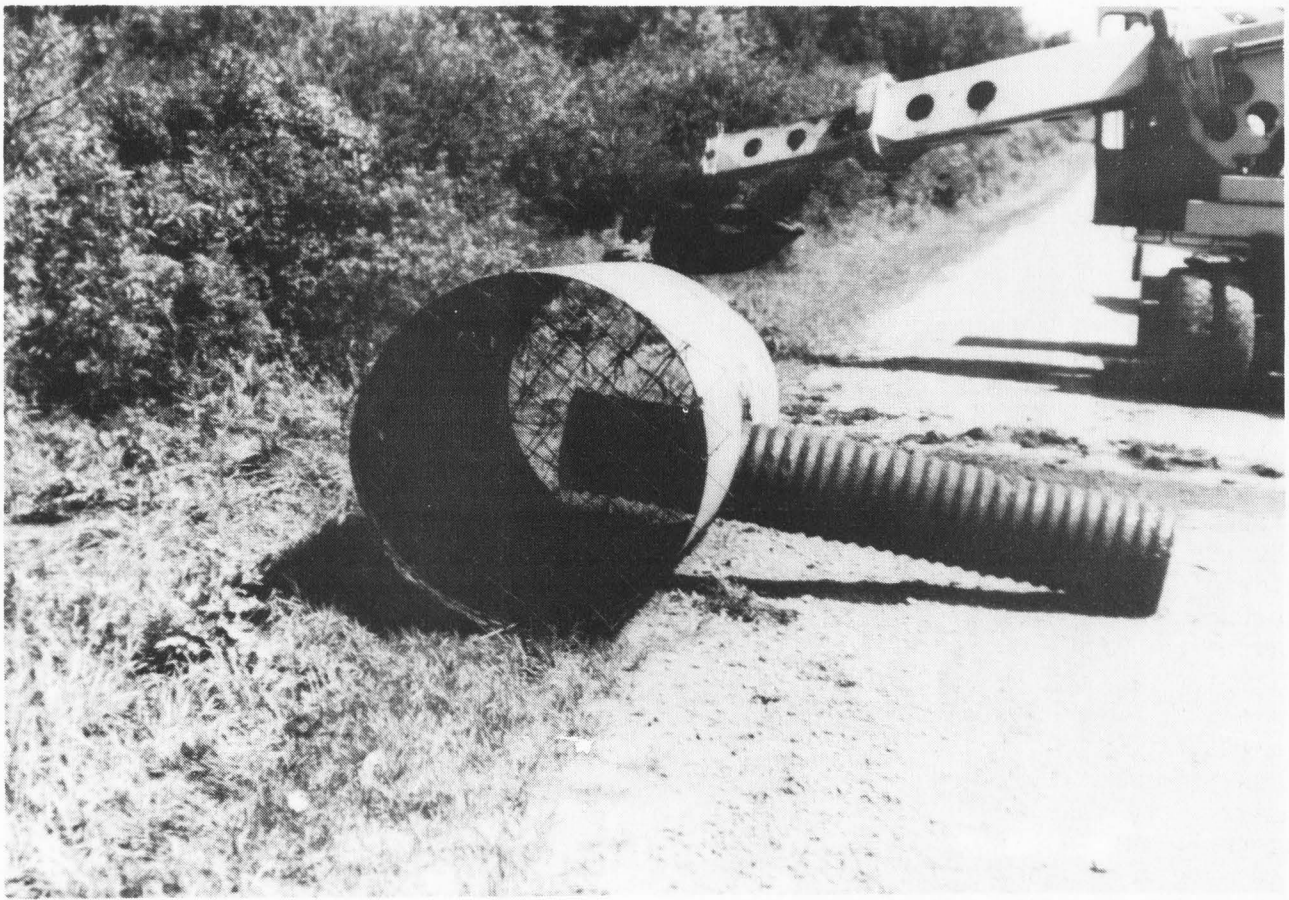
Figure 2. Large culvert showing placement of hole cut for smaller diameter connecting culvert. Wire mesh is in place on culvert ends.

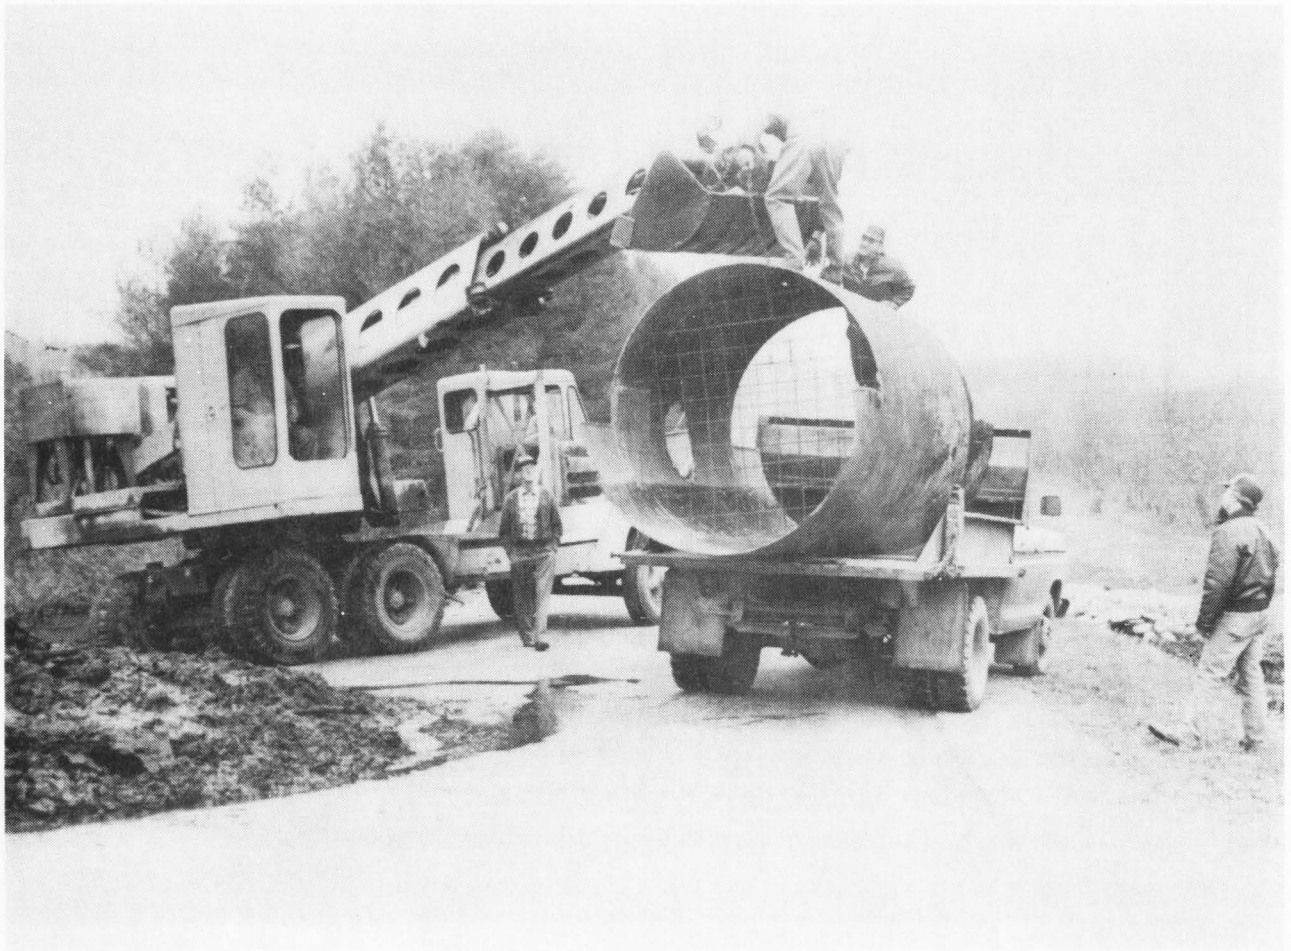
Figure 3. A 6 ft. diameter large culvert with extended ends used in fencing back unstable substrate.

Before the T-culvert can be installed at a site, sufficient water depth must be present in front of the road culvert to nearly submerge the large culvert and provide a similar water depth 6 ft. to 8 ft. outward from its ends. If this depth is not present then it must be provided by excavation. If this excavation is done in muck or gravel substrate, surrounding material may collapse or wash into the large culvert. This will reduce water depth and subsequently the effectiveness of the T-culvert. This can be prevented by fencing the unstable material back from the large culvert openings. One method of fencing is to place stone filled wire gabions around and 6 ft. distant from the openings. Another method is to cut the large culvert so that the bottom half of the culvert ends extend approximately 3 ft. beyond the wire grate coverings as shown in Figure 3. Plywood is then placed against the extended ends to hold back loose substrate.

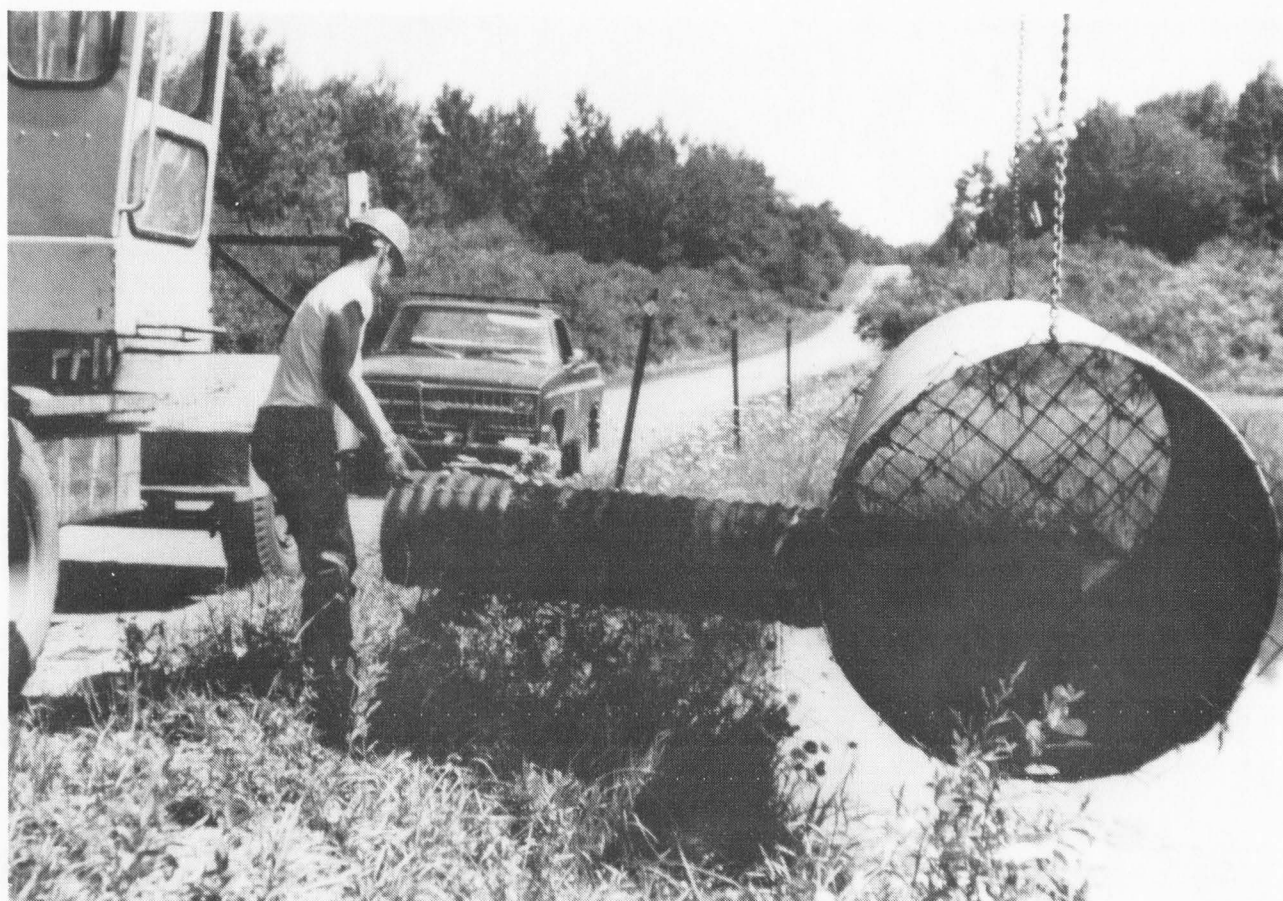
Figure 4. Lowering assembled T-culvert in place in front of road culvert.

The T-culvert assembly is most easily installed by placing 1 ft. to 2 ft. of the connecting culvert into the large culvert and then lowering the assembly into position (Figure 4). The large culvert is placed 4 ft. to 6 ft. from the inlet end of the road culvert in a position perpendicular to the road culvert and parallel to the road surface. The entire assembly is then moved toward the road culvert as the remaining end of the connecting culvert is placed 6 in. into the road culvert. Any remaining opening of the road culvert not covered by the connecting culvert should be covered with No. 6-gauge

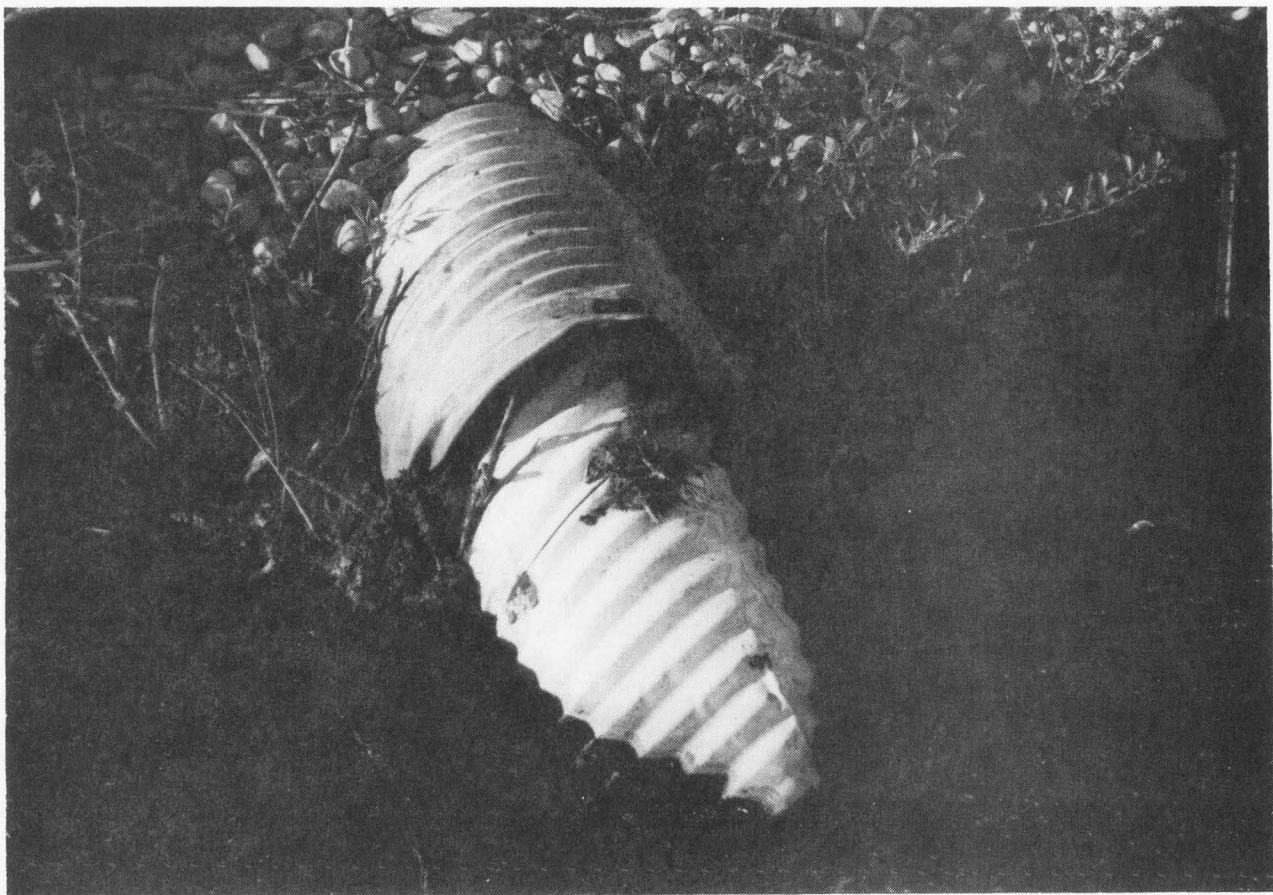
Figure 5. Smaller diameter connecting culvert in place in road culvert.

reinforcing mesh to exclude beaver. Figure 5 shows the proper placement of the connecting culvert into the road culvert. It may be necessary to place a small amount of excavated material behind the large culvert to prevent it from rocking. Figure 6 shows a completed T-culvert installation which uses extended ends and plywood fencing to exclude muck substrate.

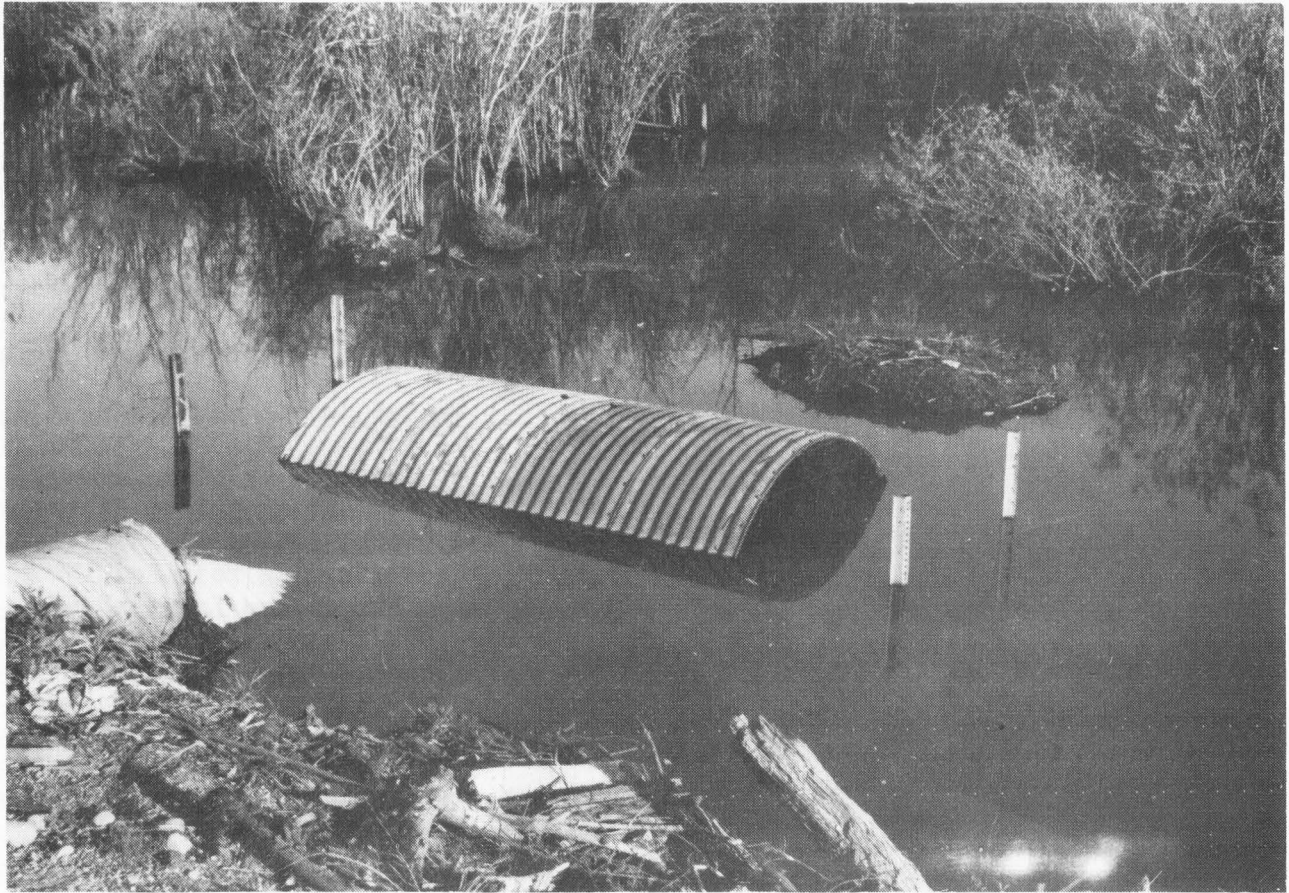
Figure 6. T-culvert shown in Figure 3 in place. Metal posts support plywood fencing against the extended culvert ends.
